NTA 8713 In practice / In de praktijk

Project

Reuse of 14 columns in the façade of a new building

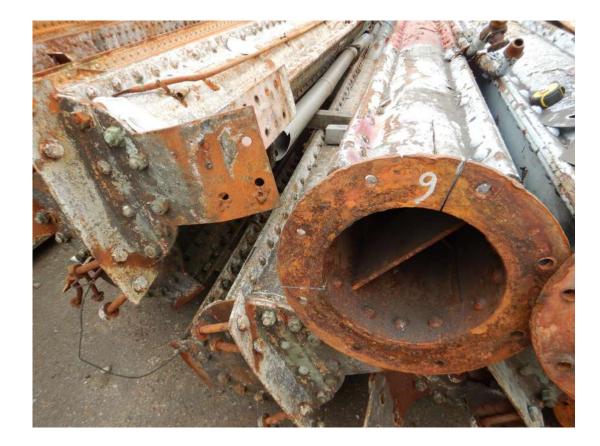
Visual inspection

- No major nonconformities
- Coating suspected of containing chromium and / or lead

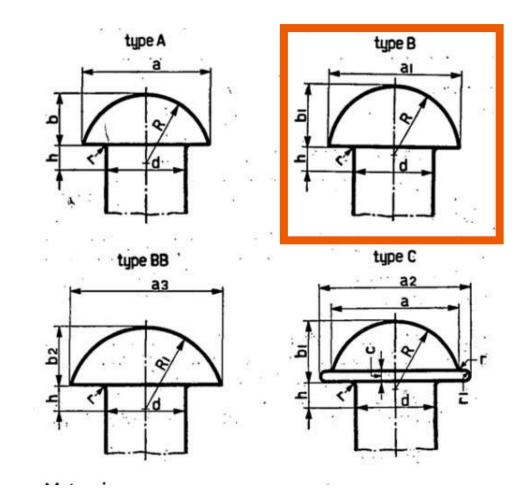
Material of the sections is a cast steel variant The material properties are equal or higher than the assumptions Rivets are larger than expected Cross plates are not yet included in the engineering
