NTA 8713 In practice / In de praktijk

Project

Reuse of 14 columns in the façade of a new building

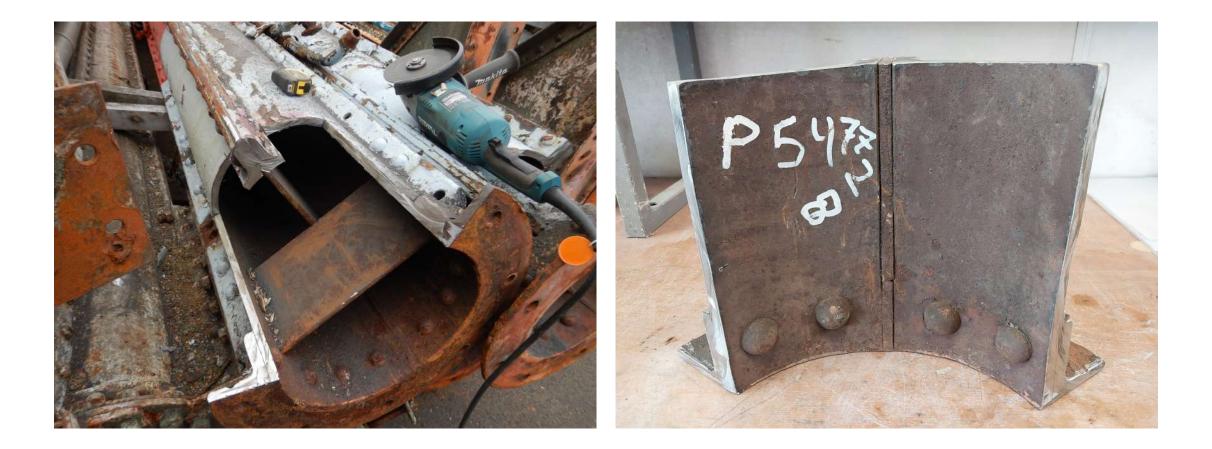
- No major nonconformities
- Coating suspected of containing chromium and / or lead

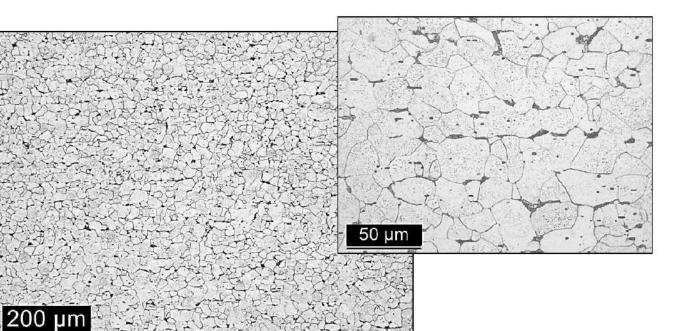
Material of the sections is a cast steel variant The material properties are equal or higher than the assumptions Rivets are larger than expected Cross plates are not yet included in the engineering
